<b>ANED</b> ASOCIACIÓN NACIONAL DE ENTIDADES DE LA PROVINCIA DE MALDONADO		DIRECCIÓN CENTRAL ZONA SECTORIAL DE MALDONADO	
LOCALIDAD: PIRAPOLIS MALDONADO		FECHA: 20/12/2012 ESCALA: 1/2000	
LINDA No: L3	A3

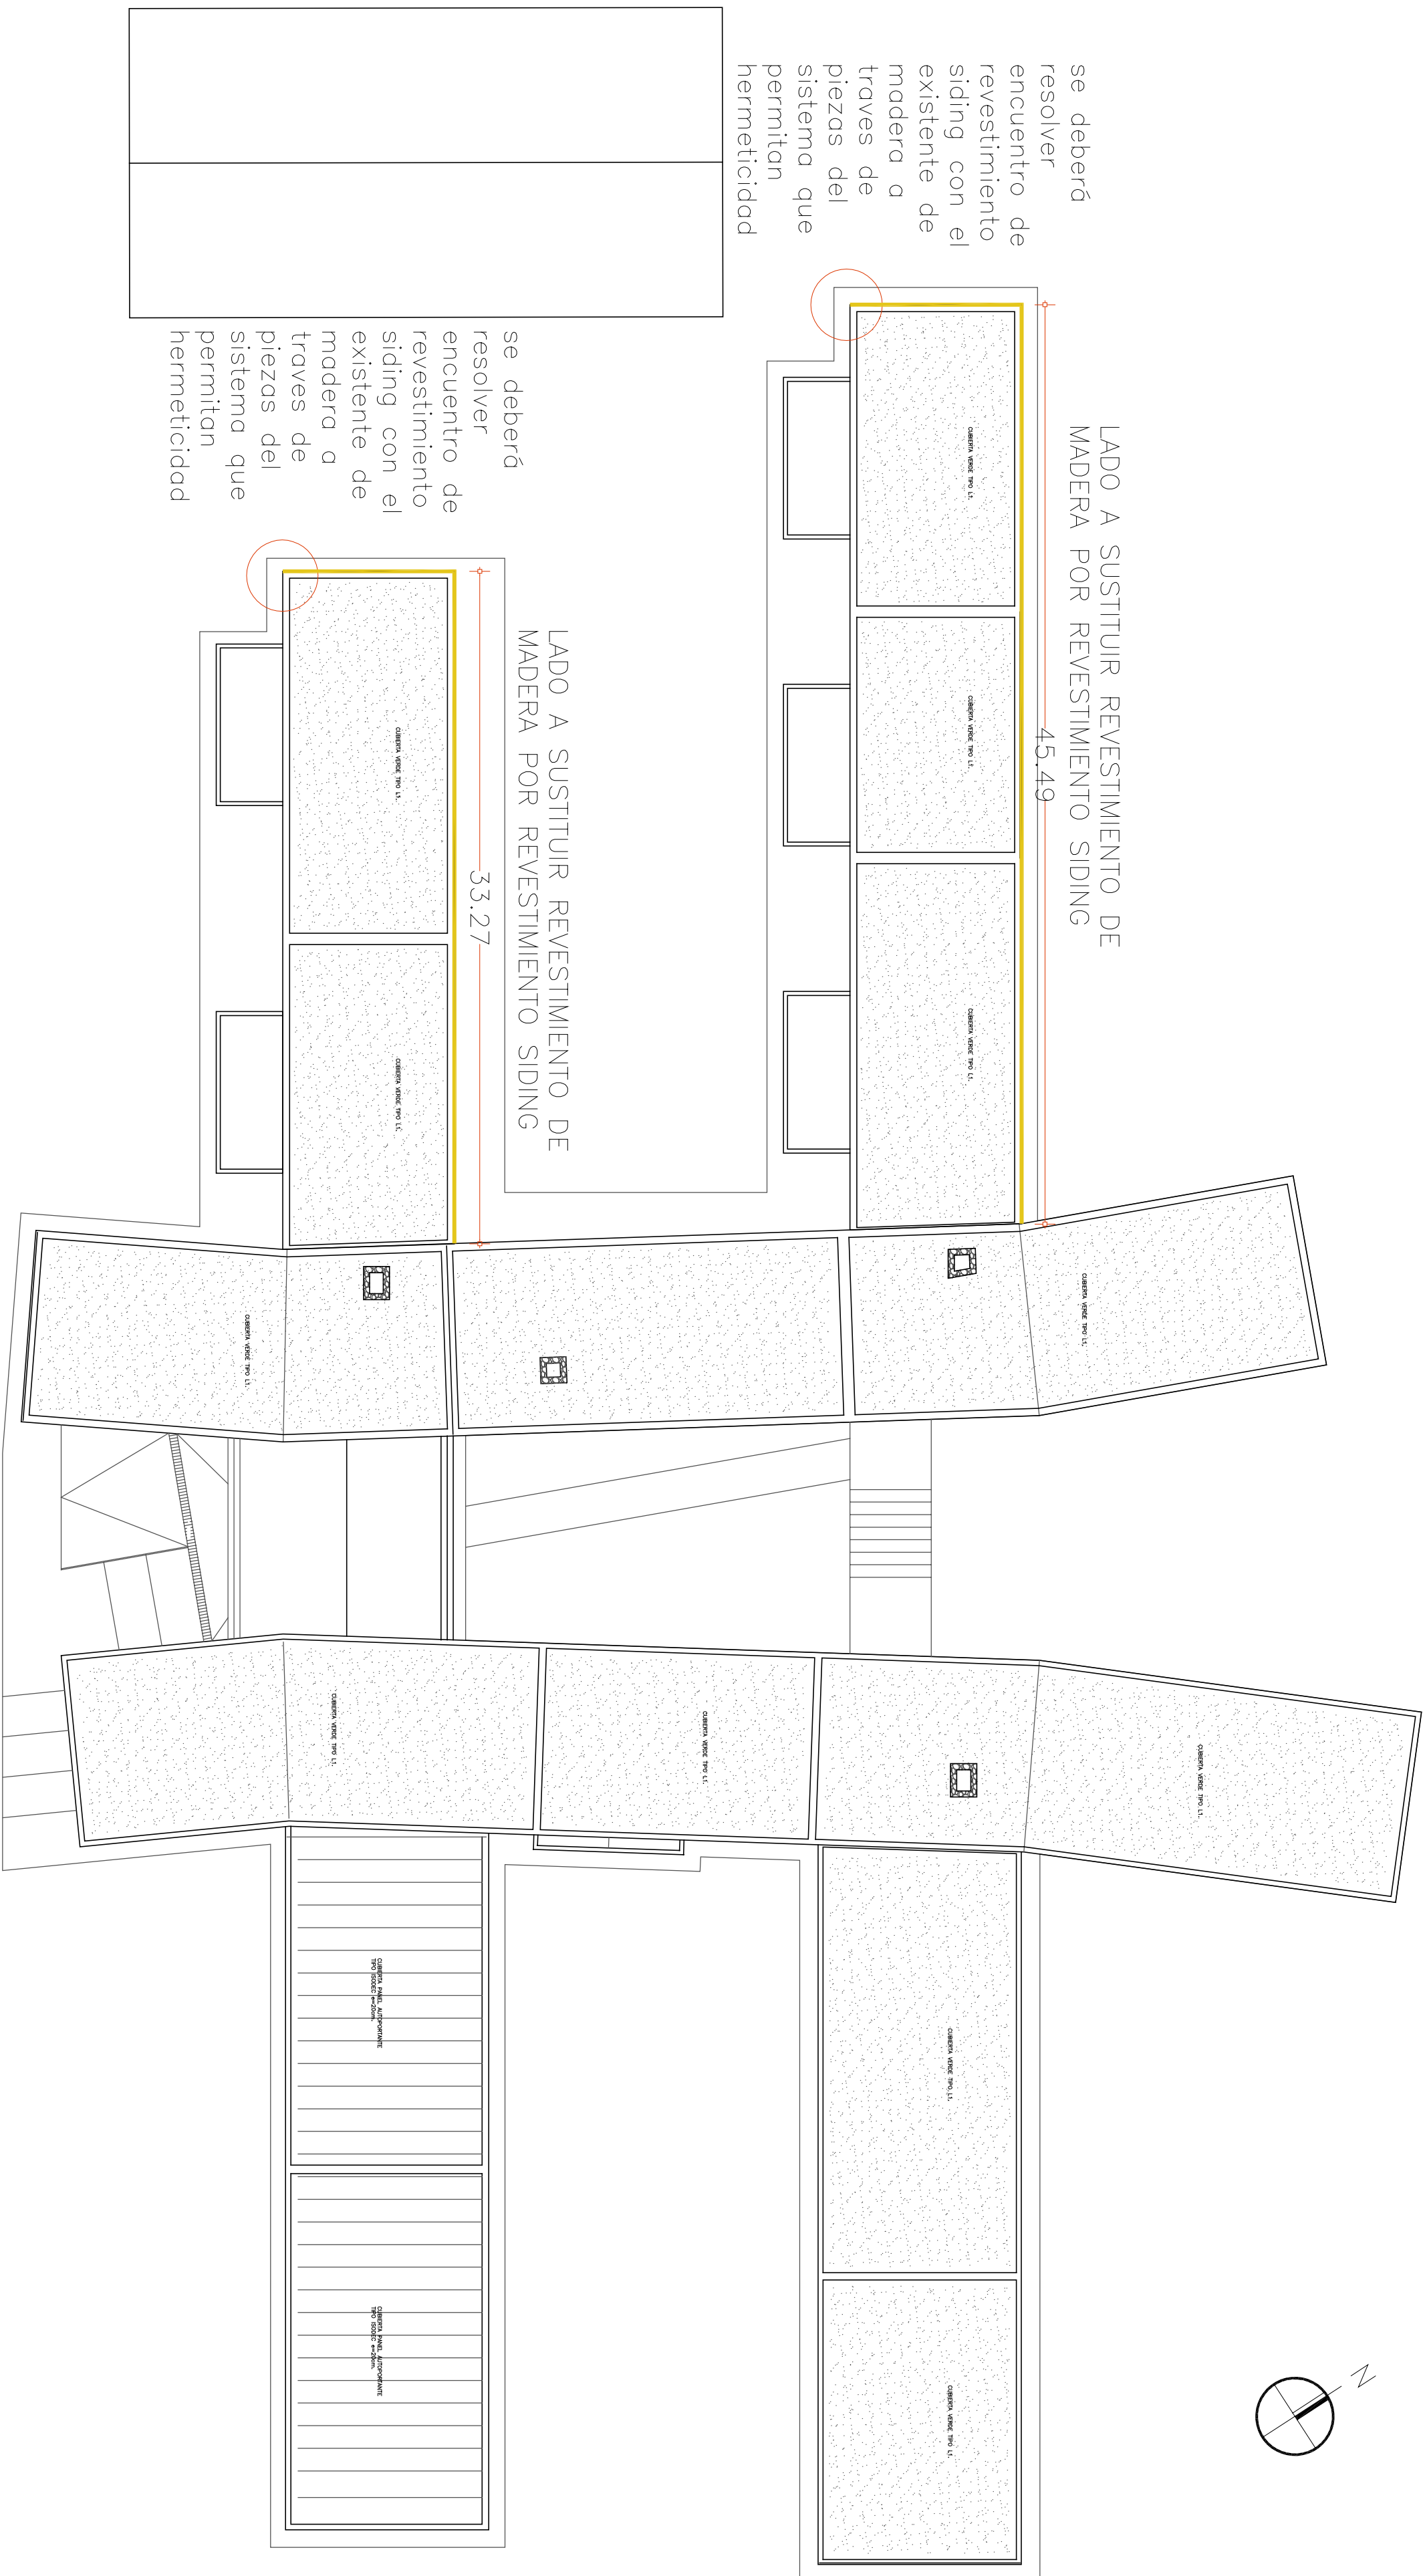
se deberá resolver encuentro de revestimiento siding con el existente de madera a través de piezas del sistema que permitan hermeticidad

Figure 33.27 shows a schematic diagram of a two-panel window. The window is divided into two vertical panels by a central mullion. Each panel contains a dense pattern of small, light-colored dots. The left panel is labeled "outside view, no L." and the right panel is labeled "inside view, no L.". The entire window assembly is set within a frame. A red circle highlights a small detail in the top-left corner of the frame.
